Lab Safety Alert

Boron trifluoride gas release

University
of Victoria

INCIDENT DATE: July 28 2022

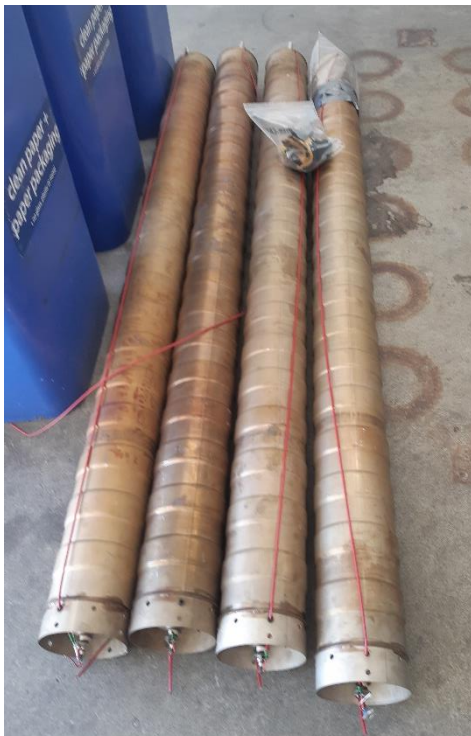
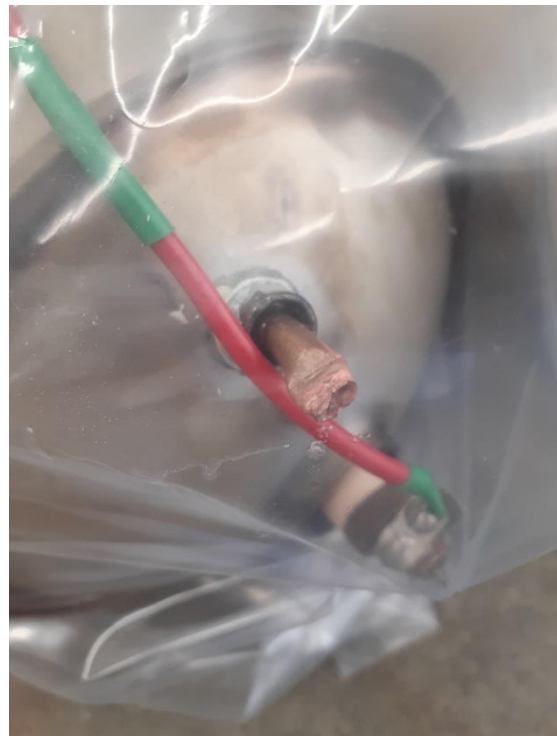
On July 22 2022, a research department worker was clearing out a stock pile of materials and equipment from a lab. Four unknown and unidentified metal cylinders were found under a bench and were given to a mechanical shop in the building to dismantle. The shop supervisor found a name plate "Chalk River". After looking online they determined the cylinders were neutron detectors developed in the 1960s and contained boron trifluoride gas under vacuum. They did not know the hazards of boron trifluoride gas. The worker cut a gas inlet at one end of the cylinder, they heard vacuum release and then a foggy gas came out. They immediately crimped the inlet to stop the gas release, decided to not further handle and submit to hazardous waste for pick up on July 28 2022. On the day of pick up by hazardous waste contractors, a shop worker moved the cylinders outside onto the loading bay for ease of pick up. They were wearing padded work gloves meant for material handling. After handling the compromised cylinder, they saw a small wisp of gas/mist emit one end of the cylinder and went to get pliers to re-crimp the gas inlet to prevent further gas release. They then noticed the glove on their right hand from handling the pliers was shriveled and discoloured. They removed their glove but did not notice any burns. The worker and supervisor then covered the compromised end with a Ziploc bag and wrapped it close with duct tape. OHSE was contacted for assistance.

Boron trifluoride is a toxic gas and when in contact with water or moisture in the air, hydrogen fluoride is produced. Hydrogen fluoride (or hydrofluoric acid) is not only a corrosive acid but it will cause tissue death (also known as necrosis). Unlike other corrosive acids, burns or exposure from hydrofluoric acid are not immediately obvious and symptoms may appear up to 36 hours after exposure.

- Identify equipment and their hazards before handling
- Review the Safety Data Sheets (SDS) of all chemicals before handling
- Contact OHSE when abnormal or unknown equipment or waste are encountered
- Conduct regular lab inspections or clean outs
- Ensure retiring or relocating professors follow lab decommissioning protocols
- Ensure any lab equipment or materials that are left behind are documented/cataloged by department administrators
