INCIDENT DATE: August 2025

BACKGROUND

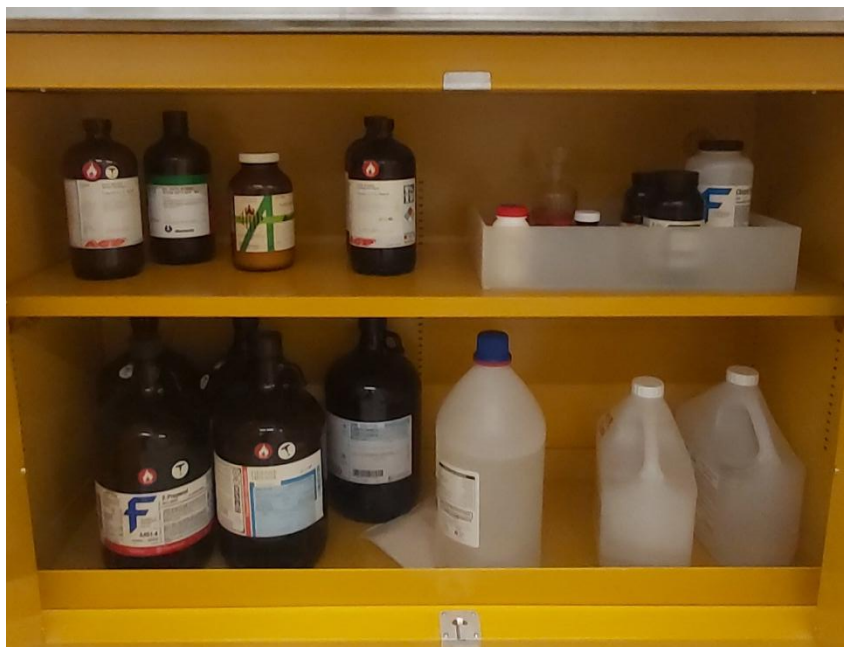
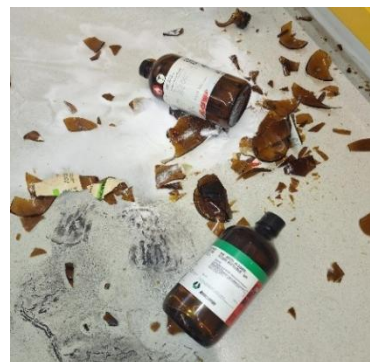
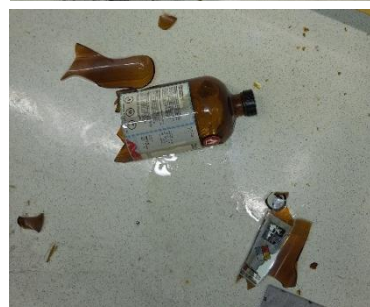
The next day, the three broken bottles were identified as triethylamine, ethyl acetate and paraformaldehyde. Triethylamine is a flammable solvent with corrosive properties and paraformaldehyde is a flammable solid. The flammable cabinet shelf was examined and found that three of the five shelf brackets had popped out such that the shelf was balancing on two brackets.

The main factor that lead to the incident is the unstable shelf in the flammable cabinet due the popped out brackets and an inadequate plan to stop it from tipping. It is unclear when other brackets popped out but it appeared they have popped out for some time prior to the incident. The researchers established the shelf was unstable and to be cautious but should have included a plan or assess how to keep the shelf stable in the process of clearing out the cabinet. Another learning outcome from this incident is the inadequate chemical inventory of the laboratory. Although the lab had a list of all the chemicals present, the locations of each chemical was not written and hampered efforts to identify what the solvents & white powder solid that spilled. Knowing in advance what the chemicals are is important to review the Safety Data Sheets (SDSs) for emergency response efforts for exposures and/or clean up.

- Inspect regularly integrity & stability of cabinet shelves that store hazardous materials
- Ensure any hazardous conditions are fully communicated and understood by all parties involved (importance of information transfer)
- Conduct hazard & risk assessments
- Ensure chemical inventories are updated annually and include locations
