# Hazard Alert

## Aqua Regia Waste Disposal

**SUBJECT:** Aqua Regia Waste Bottle Explosion

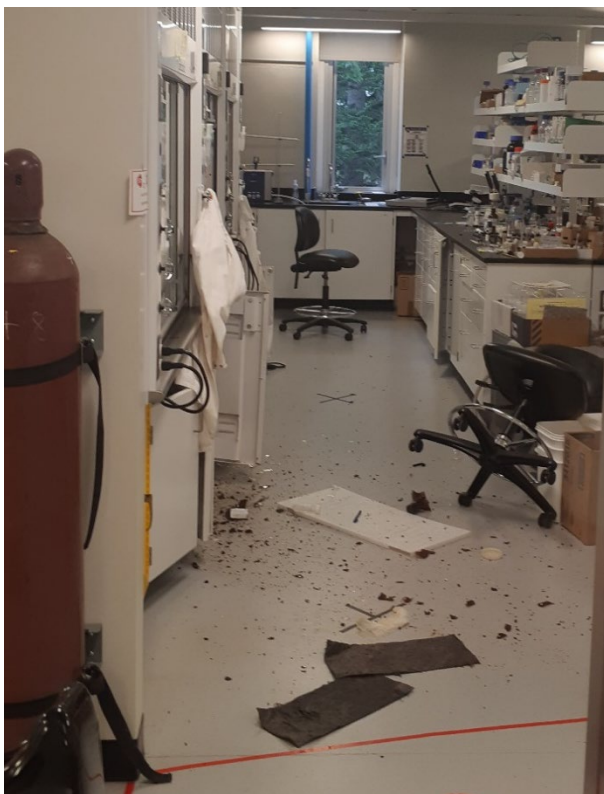
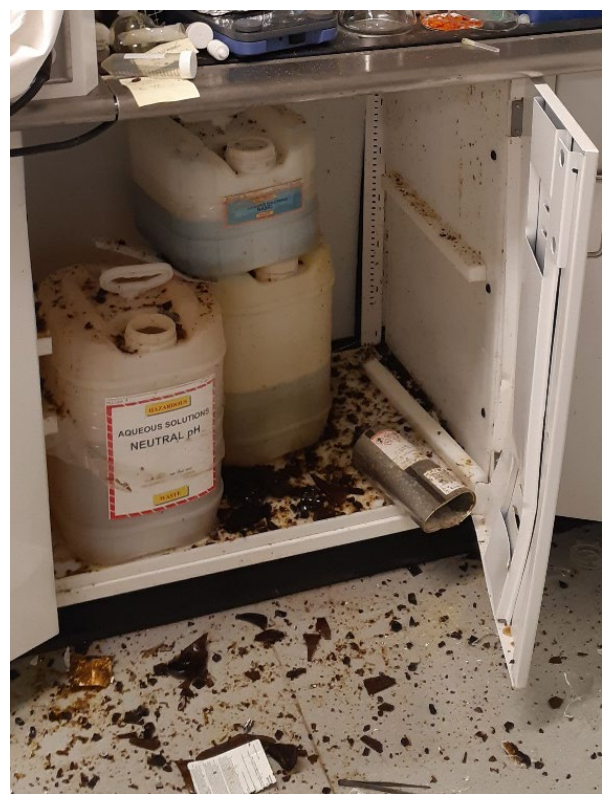
The explosion of the bottle ripped the door off the hinges of the cupboard where the bottle was stored. Approximately 3L of the acidic solution that spilled on the floor contacted and corroded two gas cylinders that were adjacent to the cupboard.

The bottle exploded because it over pressurized in a sealed container. It is believed that the bottle was mislabeled as 'dilute aqua regia' when it was actually a solution of aqua regia neutralized by excess sodium bicarbonate, these two chemicals are incompatible where carbon dioxide gas is the main product. The most likely cause for the bottle to over pressure was that a third party added more aqua regia to the bottle because the bottle was placed in a communal location. Hence, gas build up of carbon dioxide was most likely produced from the reaction of the added aqua regia and excess sodium bicarbonate.

The explosion could have been prevented if (1) the aqua regia waste bottle was labeled correctly as, for example, "aqua regia neutralized with excess sodium bicarbonate" and (2) a vented safety cap (such as Circumvent Caps) was used instead of the original bottle cap. A Circumvent cap should always be used with solutions known to be reactive and over pressurize regardless if it is for waste or not. Circumvent caps can be obtained free of charge at Science Stores.

- Use container vented safety caps (Circumvent Caps) for waste that have the potential to build pressure (regardless if neutralized)
- Accurately label waste bottles
- Ensure lab is adequately supplied with emergency supplies
- Prepare a safe operating procedure (SOP) for the safe use and handling of aqua regia with emergency protocols
