Lab Safety Alert

Aqua Regia Waste Disposal

INCIDENT DATE: March 19, 2021

SUBJECT: Aqua Regia Waste Bottle Explosion

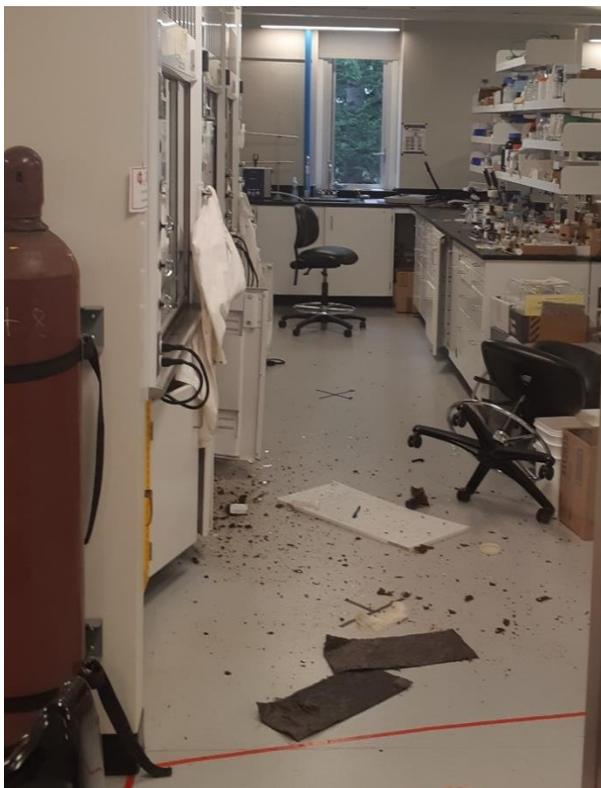
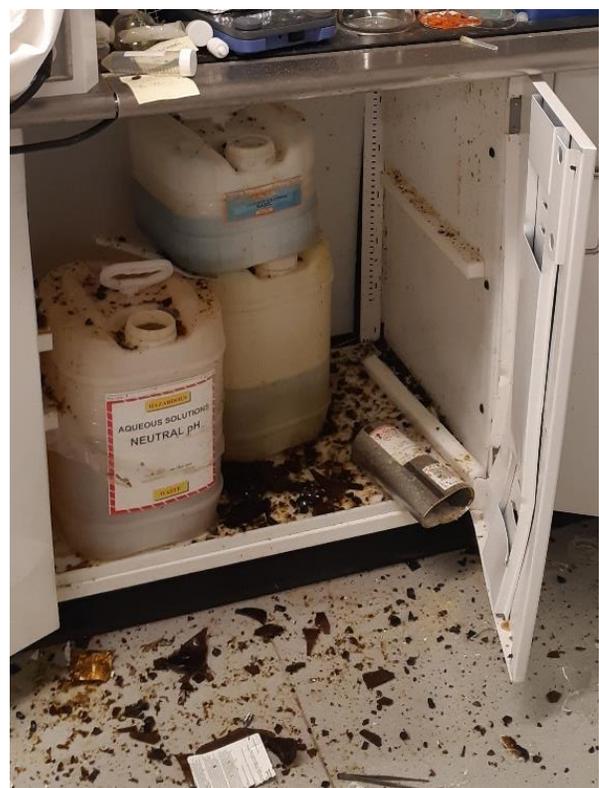
The explosion of the bottle ripped the door off the hinges of the cupboard where the bottle was stored. Approximately 3L of the acidic solution that spilled on the floor contacted and corroded two gas cylinders that were adjacent to the cupboard.

The bottle exploded because it over pressurized in a sealed container. It is believed that the bottle was mislabeled as 'dilute aqua regia' when it was actually a solution of aqua regia neutralized by excess sodium bicarbonate, these two chemicals are incompatible where carbon dioxide gas is the main product. The most likely cause for the bottle to over pressure was that a third party added more aqua regia to the bottle because the bottle was placed in a communal location. Hence, gas build up of carbon dioxide was most likely produced from the reaction of the added aqua regia and excess sodium bicarbonate.

The explosion could have been prevented if (1) the aqua regia waste bottle was labeled correctly as, for example, "aqua regia neutralized with excess sodium bicarbonate" and (2) a vented safety cap (such as Circumvent Caps) was used instead of the original bottle cap. A Circumvent cap should always be used with solutions known to be reactive and over pressurize regardless if it is for waste or not. Circumvent caps can be obtained free of charge at Science Stores.

- Use container vented safety caps (Circumvent Caps) for waste that have the potential to build pressure (regardless if neutralized)
- Accurately label waste bottles
- Ensure lab is adequately supplied with emergency supplies
- Prepare a safe operating procedure (SOP) for the safe use and handling of aqua regia with emergency protocols
