# Lab Safety Alert

## Boron trifluoride gas release

**SUBJECT:** Boron trifluoride gas release

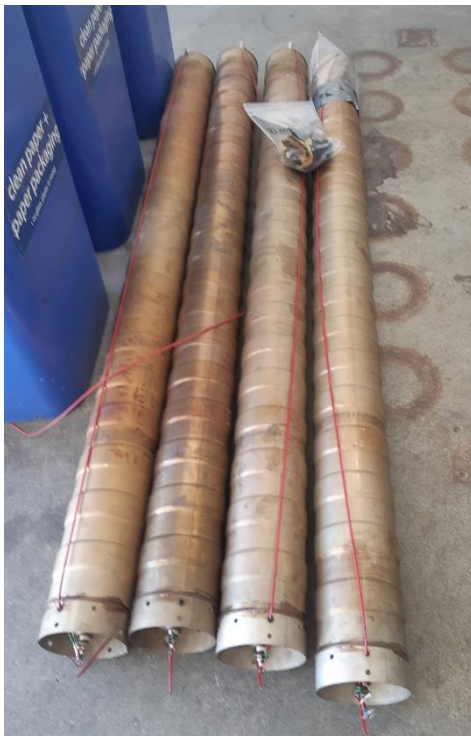
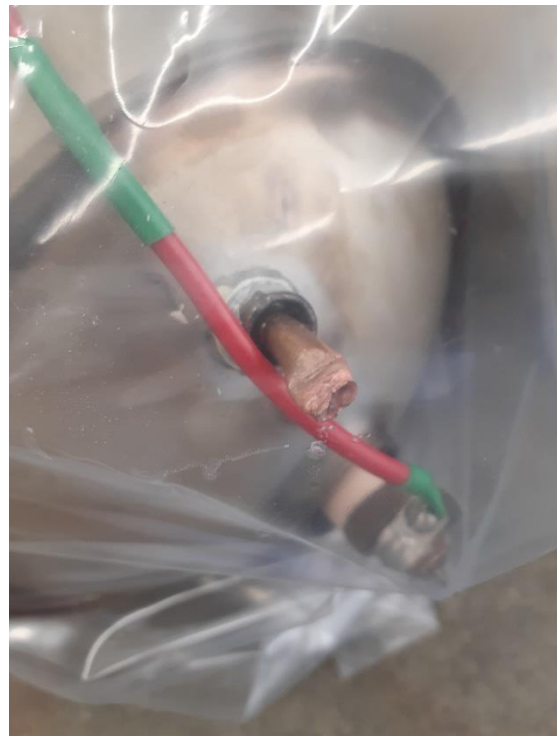
On July 22 2022, a research department worker was clearing out a stock pile of materials and equipment from a lab. Four unknown and unidentified metal cylinders were found under a bench and were given to a mechanical shop in the building to dismantle. The shop supervisor found a name plate "Chalk River". After looking online they determined the cylinders were neutron detectors developed in the 1960s and contained boron trifluoride gas under vacuum. They did not know the hazards of boron trifluoride gas. The worker cut a gas inlet at one end of the cylinder, they heard vacuum release and then a foggy gas came out. They immediately crimped the inlet to stop the gas release, decided to not further handle and submit to hazardous waste for pick up on July 28 2022. On the day of pick up by hazardous waste contractors, a shop worker moved the cylinders outside onto the loading bay for ease of pick up. They were wearing padded work gloves meant for material handling. After handling the compromised cylinder, they saw a small wisp of gas/mist emit one end of the cylinder and went to get pliers to re-crimp the gas inlet to prevent further gas release. They then noticed the glove on their right hand from handling the pliers was shriveled and discoloured. They removed their glove but did not notice any burns. The worker and supervisor then covered the compromised end with a Ziploc bag and wrapped it close with duct tape. OHSE was contacted for assistance.

Boron trifluoride is a toxic gas and when in contact with water or moisture in the air, hydrogen fluoride is produced. Hydrogen fluoride (or hydrofluoric acid) is not only a corrosive acid but it will cause tissue death (also known as necrosis). Unlike other corrosive acids, burns or exposure from hydrofluoric acid are not immediately obvious and symptoms may appear up to 36 hours after exposure.

- Identify equipment and their hazards before handling
- Review the Safety Data Sheets (SDS) of all chemicals before handling
- Contact OHSE when abnormal or unknown equipment or waste are encountered
- Conduct regular lab inspections or clean outs
- Ensure retiring or relocating professors follow lab decommissioning protocols
- Ensure any lab equipment or materials that are left behind are documented/cataloged by department administrators
