Safety Alert

Muffle Oven Fire

University
of Victoria

SUBJECT: Muffle oven fire

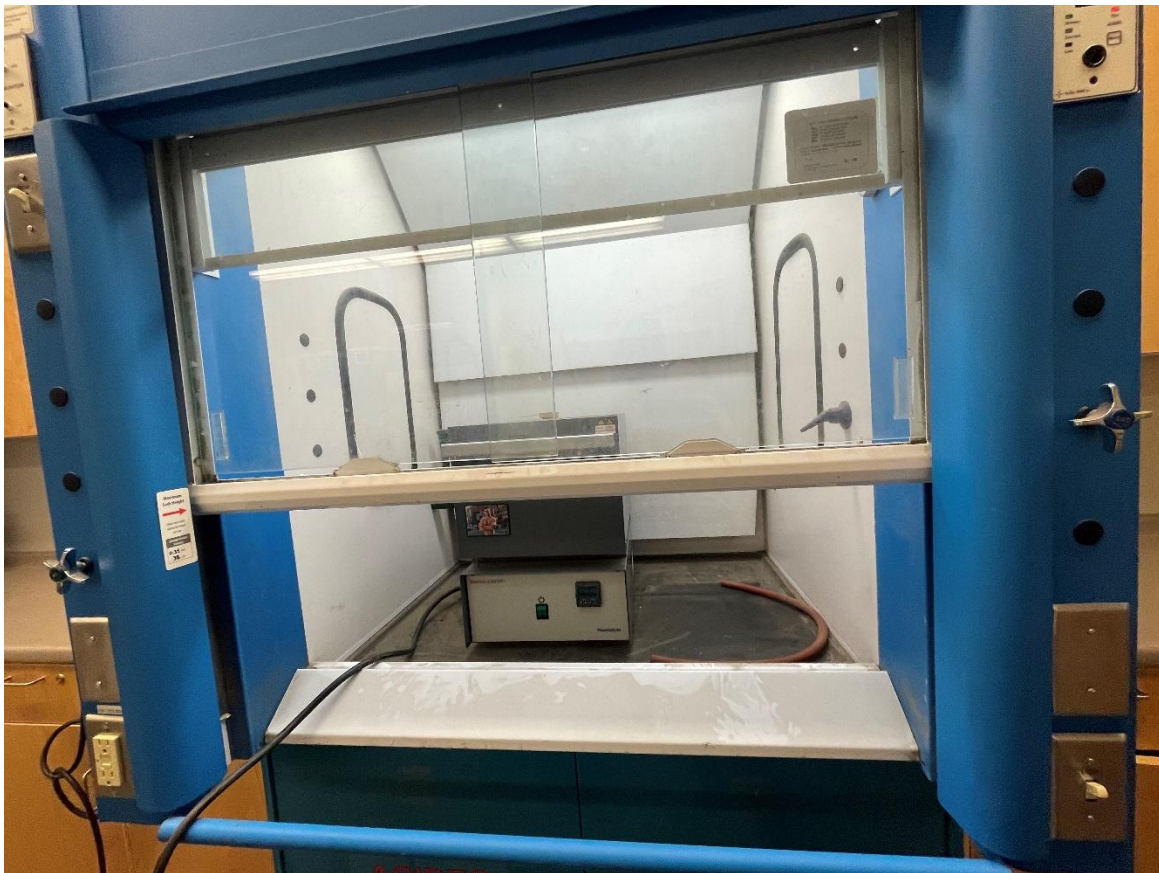
The muffle oven and fume hood were not damaged.

The student inserted the samples when the oven was up to full 550 °C temperature instead of inserting the samples first, and then bringing the oven to temperature, resulting in the samples self-igniting and a subsequent flash flame. A flash flame fire occurred because the samples within had not completely mineralized to ash.

- Ensure researchers have completed basic laboratory safety training and as well as lab specific training/orientation before working in a laboratory
- Train and orient researchers on proper handling of lab equipment prior to use.
- Supervisors must review experiments and methodology with student researchers prior to commencing work.
- Prohibit undergraduate student researchers from working alone in the laboratory
- Develop policies and procedures for shared laboratories.
